# Manhole Inspection Summary

Manhole # S25UU1019MH

**Location** Address: **7 INDIAN LN**

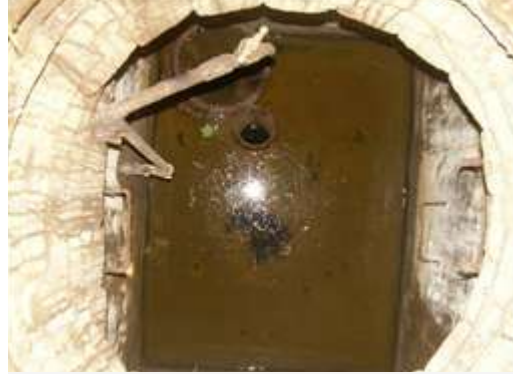
Top View

Corroded and missing steps. Channel debris.

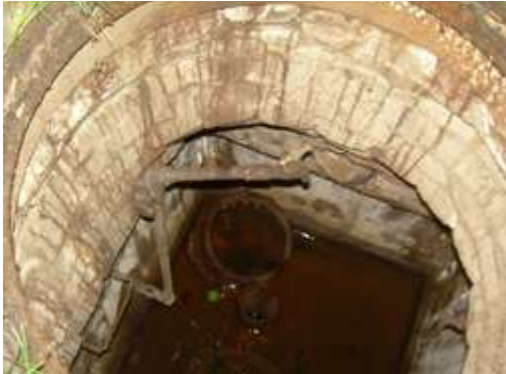
Defect

Frame leaks. Adjustment, Corbel and Barrel infiltration.

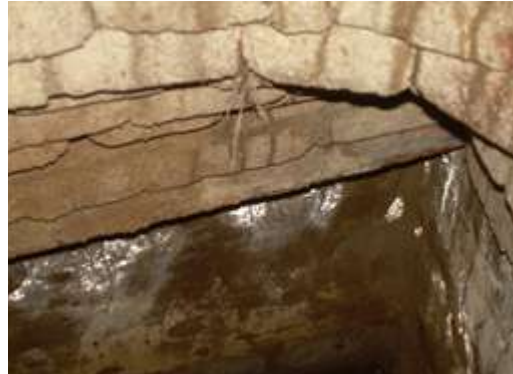
Defect

Adjustment and Barrel infiltration. Corbel root intrusion and infiltration.

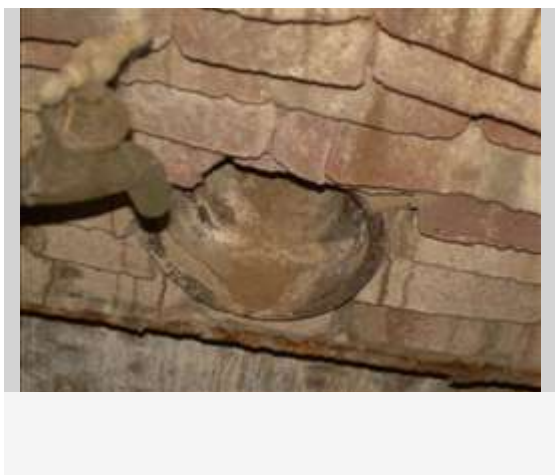
4 in. Circular Gravity Sewer  
Pipe Out @ 12 O'Clock

Infiltration: **None** Pipe Seal Cond: **Unknown**
